Manhole Inspection Summary

Manhole # S35S__070MH

Insp Date: 1/29/08 3:13 PM

Location Address: **1211 s.charles st**

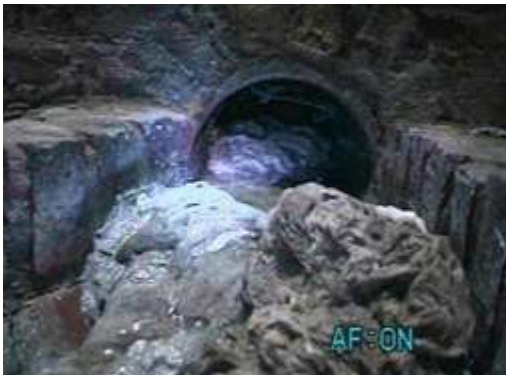
Defect 2

Condition: ☐ Sound ☐ Cracked ☐ Root Intrusion ☐ Deteriorated ☐ Leaks ☒ **Debris**

channel debris

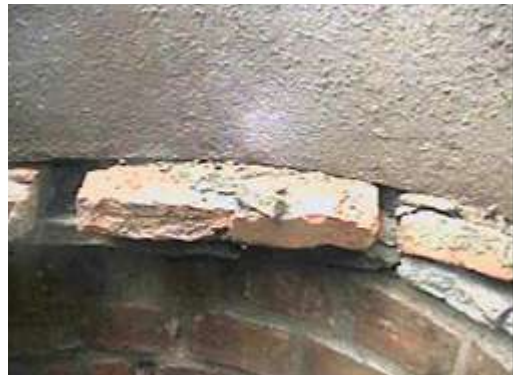
Defect 1

Condition: ☐ Sound ☐ Cracked ☐ Root Intrusion ☒ **Loose Brick** ☐ Deteriorated

loose bricks

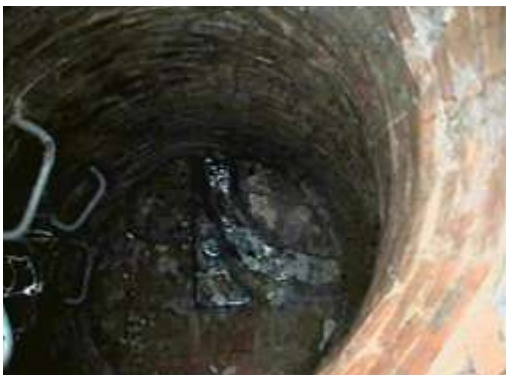
Defect 3

Condition: ☐ Sound ☐ Cracked ☐ Root Intrusion ☐ Deteriorated ☐ Leaks ☒ **Debris**

Bench Debris

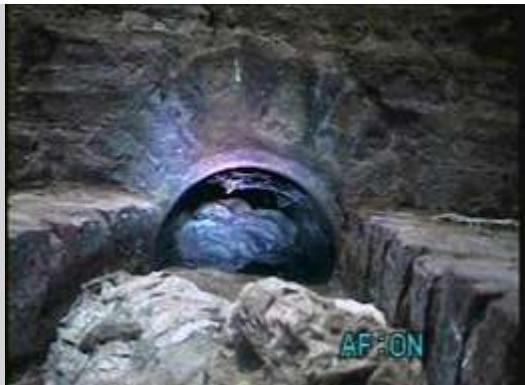
3 O'Clock Inflow

8 in. Circular Gravity Sewer
Pipe In @ 3 O'Clock

Deposits: ☐ None ☐ Mud ☐ Sludge ☒ **Debris** ☐ Grease

Silt Depth: 5 (in.) Deposits Extent: **Heavy**

Infiltration: **None** Pipe Seal Cond: **Roots**
